HONEYWELL INC HOPKINS MN DEFENSE SYSTEMS DIV
XM587E2/XM724 ELECTRONIC TIME FUZES SYSTEM VERIFICATION TEST PH--ETC(U)
JAN 78 J C RAVIS

HDL-CR-78-157-1

JANUARY 1978

Prepared by
HONEYWELL INC.
DEFENSE SYSTEMS DIVISION
600 SECOND STREET NE
HOPKINS, MINNESOTA 55343

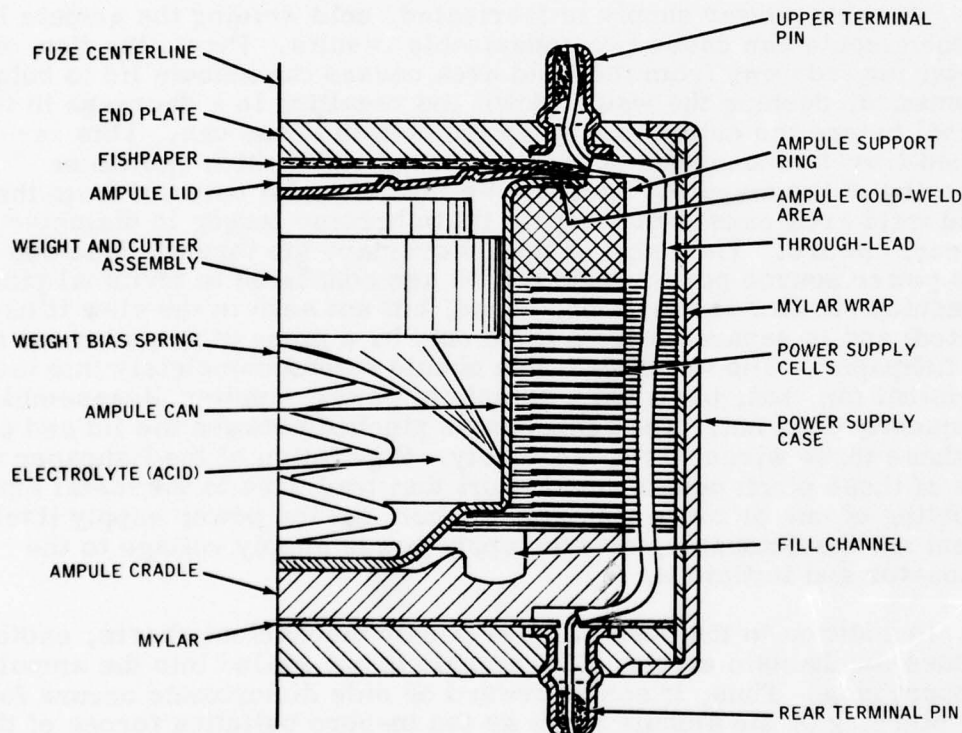
Figure 9. Cross-sectional view of the SVT vintage power supply.

2.3.2 Power Supply -- A partial section view through an SVT vintage fuze power supply is given in figure 9. The section is such that the detonator through-lead may be seen running from one terminal to the other through a scallop in the outer edge of the cell stack. The upper terminal is electrically connected to the fuze firing circuit. The lower terminal is electrically connected to the detonator bridgewire. Application of power supply power to this lead has been demonstrated to be adequate to reliability initiate the electric detonator.

When the power supply is fabricated, cold welding the ampule lid to the ampule can cause two undesirable results. First, the flow of metal inward away from the weld area causes the ampule lid to bulge downward, pushing the weight down and resulting in a decrease in the travel before the cutter tips touch the bottom of the can. This reduced travel reduces the base-down drop height which can cause piercing of the ampule. Second, the flow of metal outward from the cold weld area causes the ampule lid to become larger in diameter and to curl upward. This edge of the lid overlaps the through-lead and the two power source power leads (which are connected to terminal pins in a fashion similar to the through-lead, but not seen in the view illustrated) and is separated from them only by a piece of polyethylene coated fishpaper. The wire insulation should extend completely into the terminal pin, but, based on a sample of power supplies disassembled, frequently does not. The fishpaper is pinched between the lid and each of these three wires during assembly. Separation of the fishpaper and one of these pinch points would short that lead wire to the metal ampule. Shorting of one or more leads could short out the power supply itself, short out the detonator, or even apply power supply voltage to the detonator and initiate it.

In addition to the possibility of purely mechanical shorts, another failure mechanism exists. The ampule is not sealed into the ampule support ring. Thus, if some forward or side disturbance occurs following piercing of the ampule (such as the in-bore balloting forces of the 175mm gun), it is possible for some of the excess acid remaining in the fill channel to be splashed up between the ampule and the support ring and onto the fishpaper. The fishpaper absorbs the acid and becomes conductive, especially in thin sections. Depending on how much acid is splashed in this manner and where, it is possible to short any combination of terminal wires to the ampule lid. This electrolyte splashing and terminal shorting has been demonstrated using a jolt machine. It is also conceivable that the acid could be splashed onto the fishpaper at one point only and would, after a delay of a few seconds, spread through the fishpaper and cause two terminal leads to be shorted to the ampule lid. If the two leads thus shorted were the through-lead

and a power source power lead, then a delayed functioning of the electric detonator would result. This is the only known single failure mechanism which could cause a 4-5 second function of a fuze set to 90 seconds, and it is believed to be the most likely cause of the early burst at YPG during 175mm gun testing.

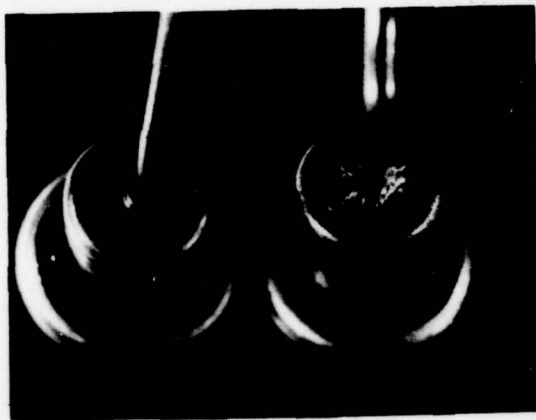
Photo 1 - MAG10X

The Kaupp switch is on the left. The Accudyne switch is on the right. Note the difference in weld appearance.

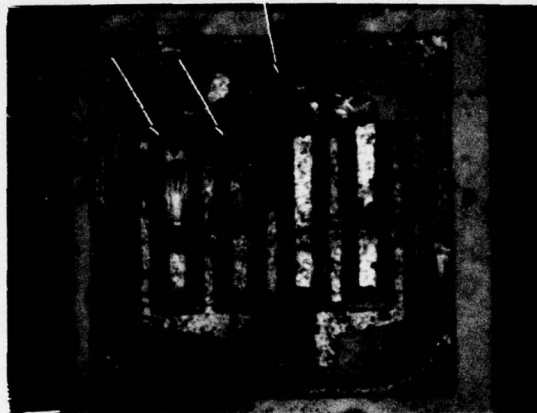
Figure 3 - Mag. 165X

Transistor Q8 emitter metalization shows signs of overstress. The arrows indicate the open circuit.

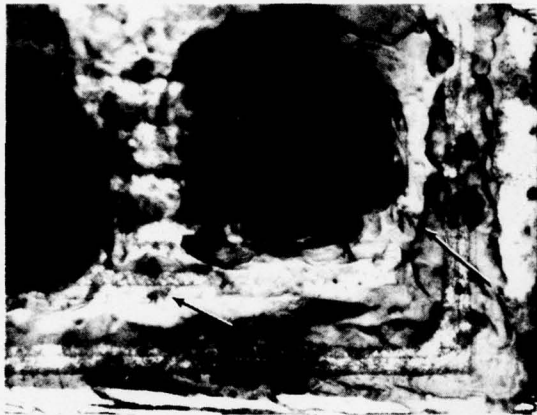
Photo 5 - Mag. 400X

The right side of the
Q3 die shown in Photo 4.
Arrows indicate dendrites.

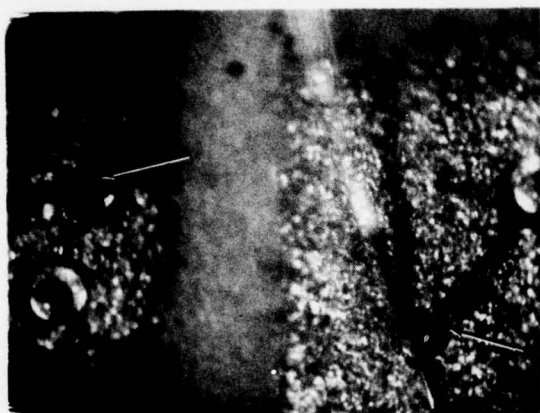
Photo 7 - Mag. 110X

The stitch and safety bonds on the Q3 emitter and base leads. Note the discoloration.

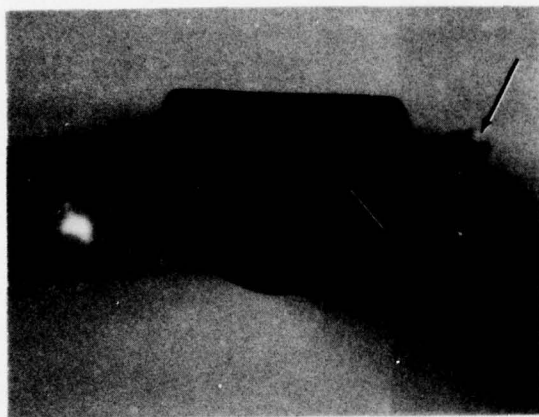
Photo 11 - Mag. 10X

External view of the bottom of transistor 2N6010. Note the crack in the epoxy encasement near the emitter lead. The top arrow identifies the emitter lead.

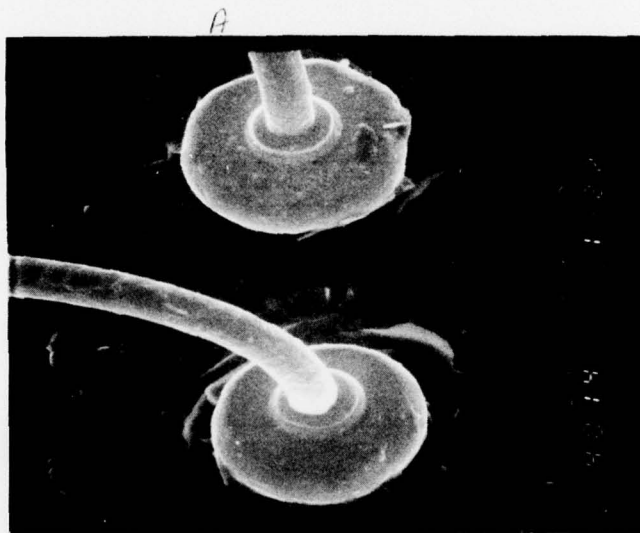
Figure 7.
400 X

DEVICE/PART NO. XM-587 Hybrid CUSTOMER B. Goblish
ENGINEER D.J. Hajicek MODE Secondary and X-ray
FIGURE 7. Q2, ball bonds which were discolored.

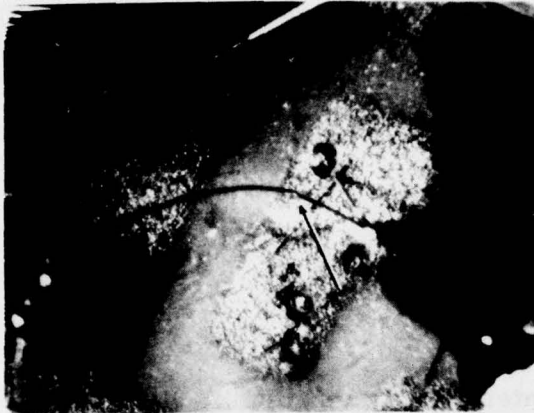
Figure 3 - Mar. 30X

Transistor Q1 emitter
lead broken.
